SAMSUNG® SF-830

DRUM CARTRIDGE REMANUFACTURING INSTRUCTIONS

REMANUFACTURING THE SAMSUNG SF-830 DRUM CARTRIDGE

By Mike Josiah and the Technical Staff at UniNet

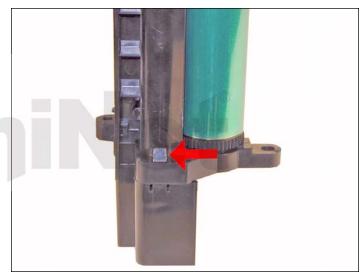
1. Remove the screw located on the waste chamber.

Press in on the tab, and remove the waste chamber.

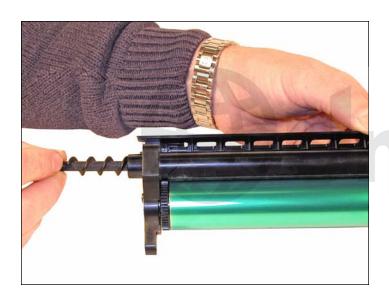
2. Remove the waste auger from the cartridge.

The augers drive gear will come loose at this point.

Remove the gear, and place aside (the gear is on the opposite side of the cartridge).

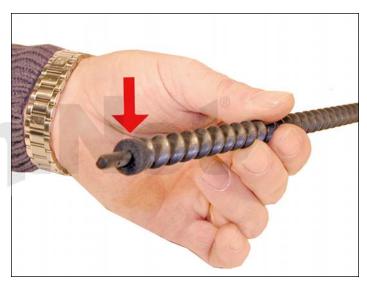
3. Vacuum the auger and foam seal clean.

Vacuum and dump out any remaining bulk toner on the auger's chamber.

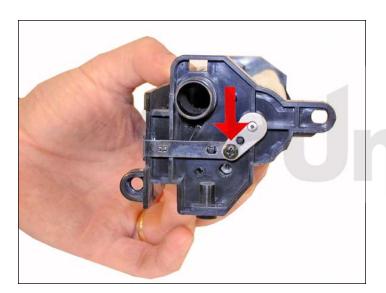
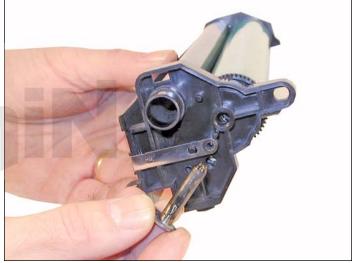
4. Remove the screw on the drum axle, and the drum axle pin.

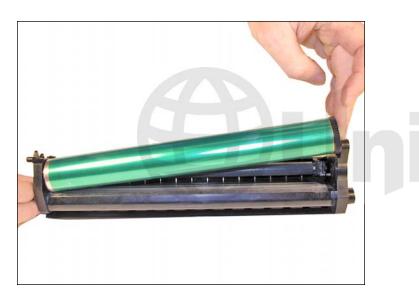
6. Remove the drum.

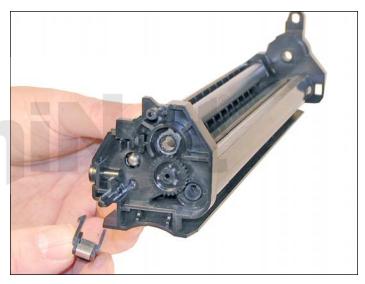
7. On the right side of the cartridge, remove the screw and contact insert.

The insert can be removed by pressing in on the plastic tabs.

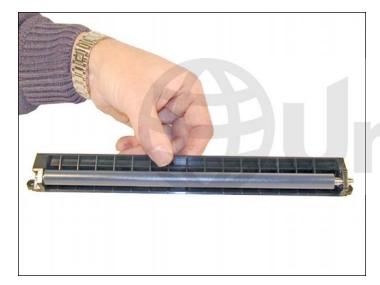
12. Clean the PCR with your normal cleaner used for Samsung cartridges. Wipe off the old conductive grease from the shaft. Re-install the PCR in the assembly. The longer bullet shaped end of the PCR is the right side.

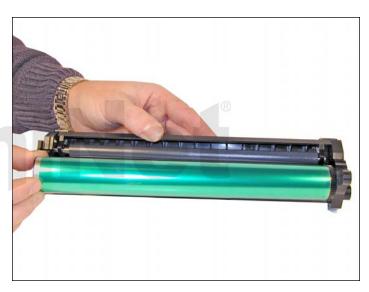
15. Install the drum gear side to the right. As with the wiper blade, the OEM drum if in good shape should run another cycle. Further than that is not a good idea.
