BROTHER™ HL 5200 (TN 550 / 580) CARTRIDGE REMANUFACTURING INSTRUCTIONS

BROTHER™ TN 580 MONOCHROME TONER CARTRIDGE

REMANUFACTURING THE BROTHER HL 5200 SERIES TONER CARTRIDGES

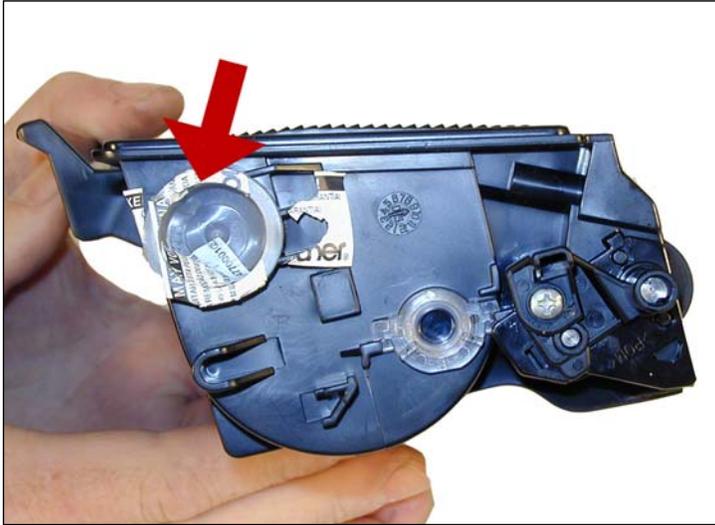
1. Remove the fill plug from the toner cartridge.

Dump the remaining toner and vacuum/blow out the cartridge. Make sure that the gear area is clean. Leaving any toner in the teeth of the gears may cause a tooth to be damaged and cause a clicking noise. We have found it best to use compressed air to clean them out, but to also keep one hand over the gears to protect them

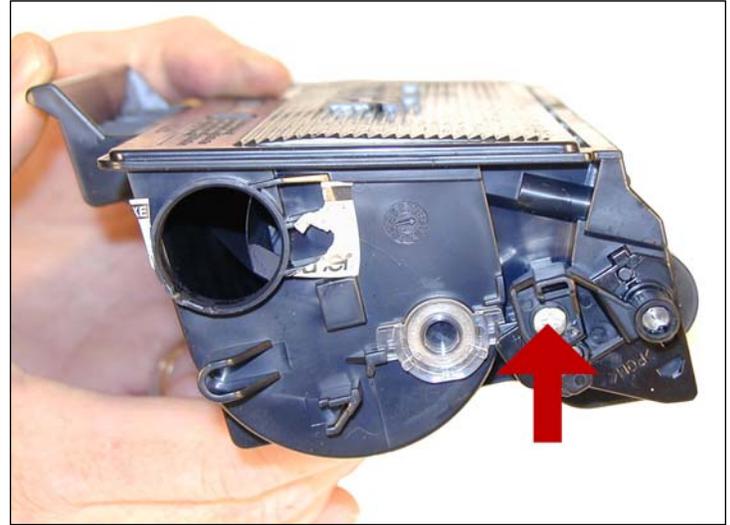
2. On the NON GEAR side of the developer roller, remove the screw.

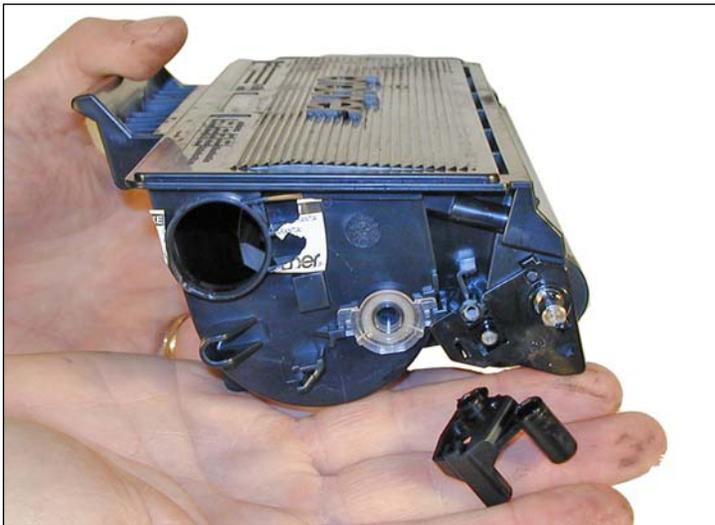
3. Remove the drum axle plate.

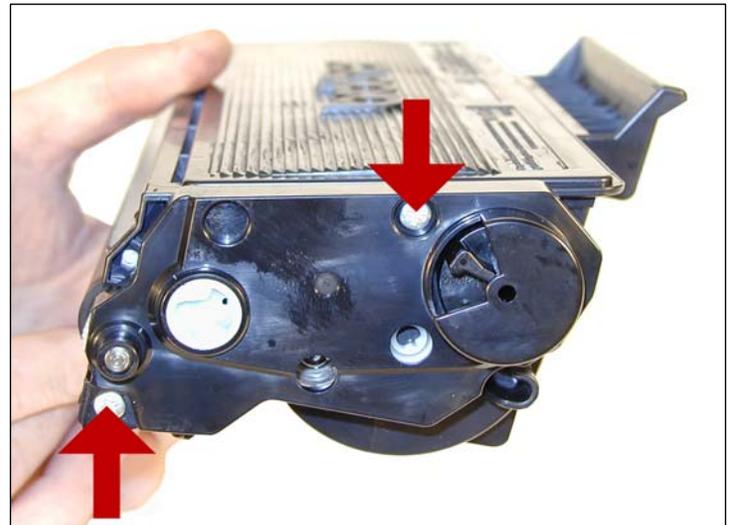
4. On the GEAR SIDE, remove the two screws and cover plate.

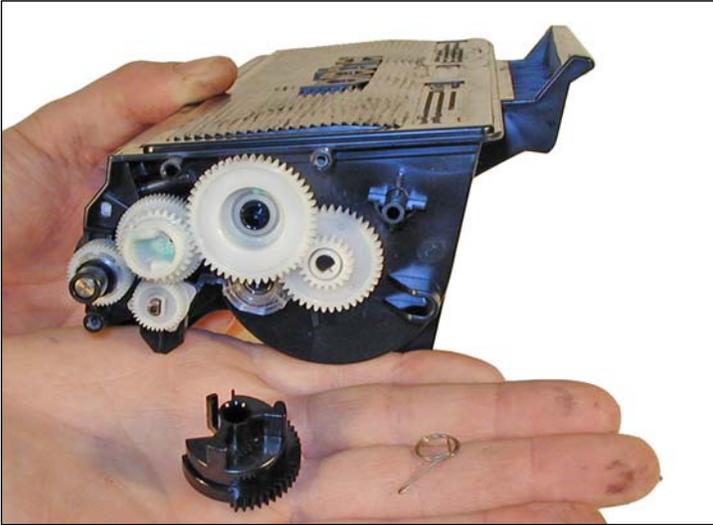
5. The black spring loaded reset gear may fall off as the plate is removed. This gear resets the printer when the cartridge is installed. New starter cartridges do not have this reset gear. Until they are available, the starter cartridges cannot be remanufactured.

Similar to the TN-350, there is a reset gear that resets the printer. The TN-550 reset gear is different from the TN-350 though. Like the TN-350, the starter cartridges that come with new printers do not have this gear. There are actually two different reset gears for TN-550/580 cartridges, one for the low yield (550) that has one reset rib, and another for the high yield (580) that has two reset ribs. These gears work by the gear train turning the reset gear and the ribs(s) of the gear press against a new toner actuator bar in the machine. If one rib engages the actuator, it is sensed as a low yield cartridge, if two ribs engage the actuator, it is sensed as a high yield cartridge. We are working on both styles of reset gears, but until dedicated TN-550 gears become available, the starter cartridges cannot be remanufactured.

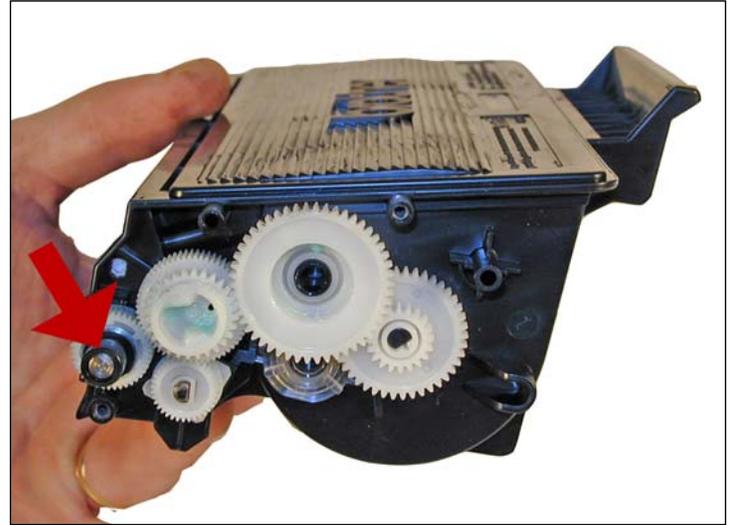
6. Remove the black plastic spacer from the developer roller shaft.

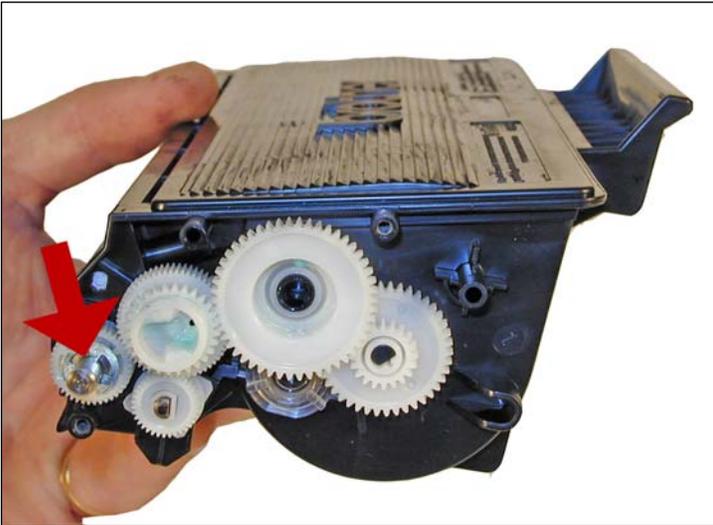
7. Remove the E-Ring, and small gear.

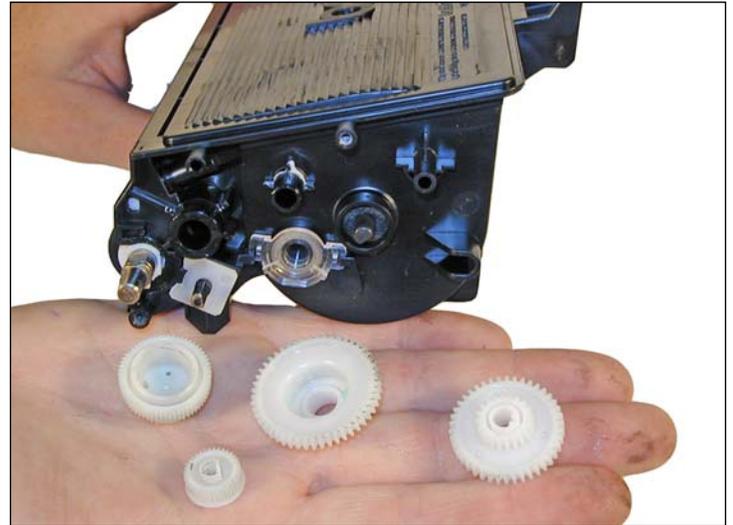
8. Remove all the remaining gears.

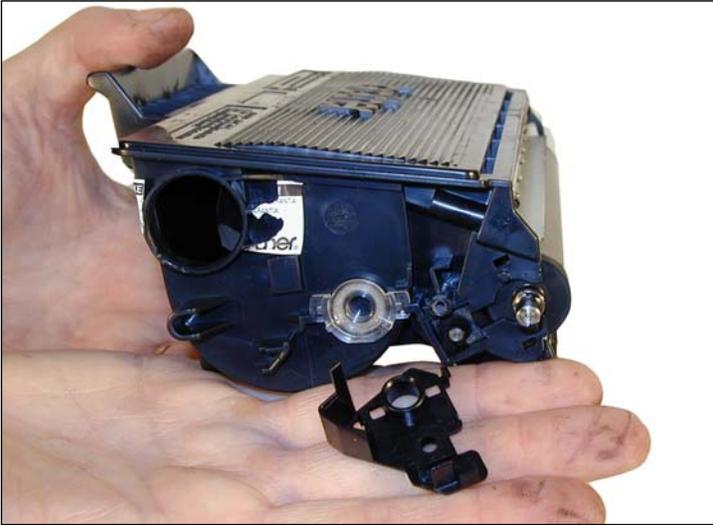
9. Remove the non-gear side end cap by gently prying it off.

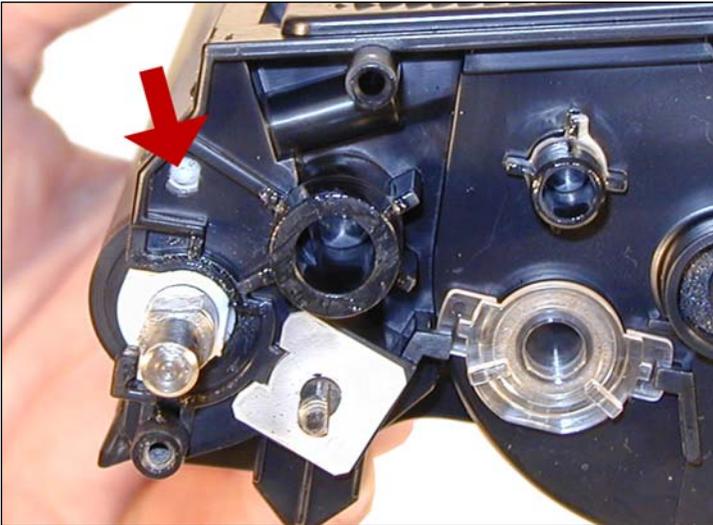
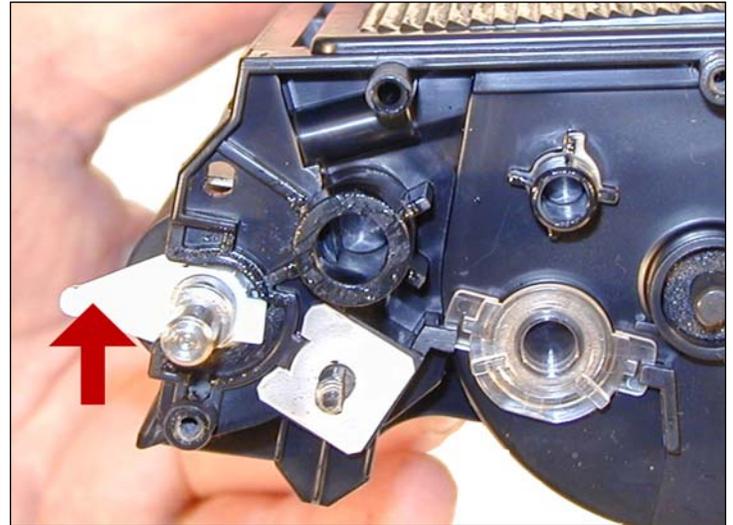
10. On the gear side of the developer roller, press in on the locking tab, and rotate the developer roller lock up.

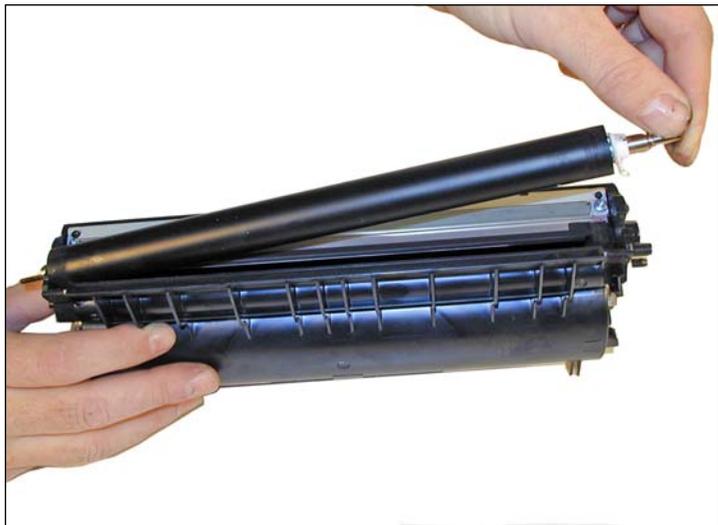
11. Remove the developer roller.

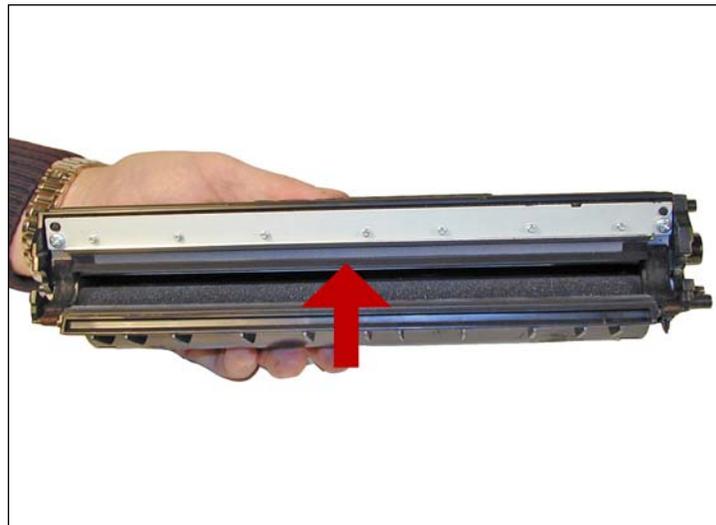
12. Vacuum the doctor blade and foam feed roller clean. We do not recommend that the doctor blade be removed and the developer roller felt seals will be disturbed. Once a new blade is available, great care will have to be taken not to tear the seals, causing a leak. The doctor blade can be easily cleaned by blowing the excess toner off, and wiping down with a lint free cloth. Be very careful not to leave any lint behind!

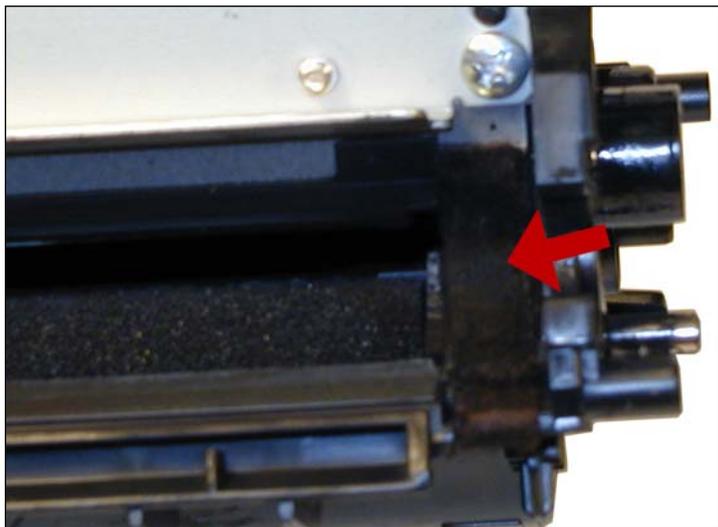
13. Inspect the magnetic roller felts. If they are compressed, (shiny) rough them up with a small screwdriver.

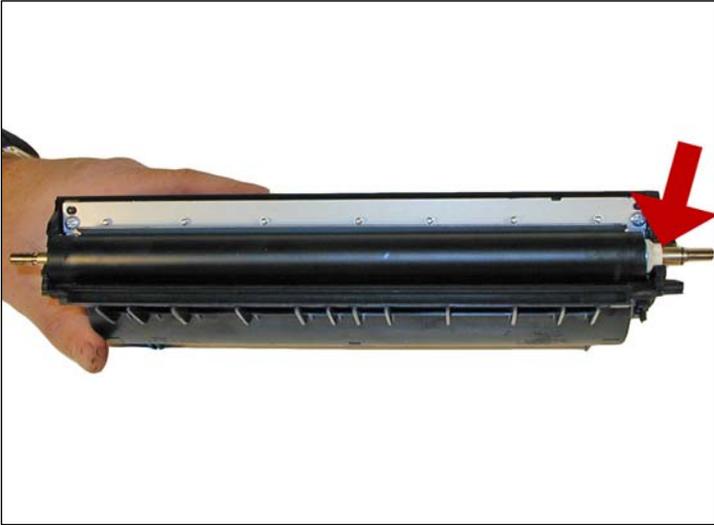
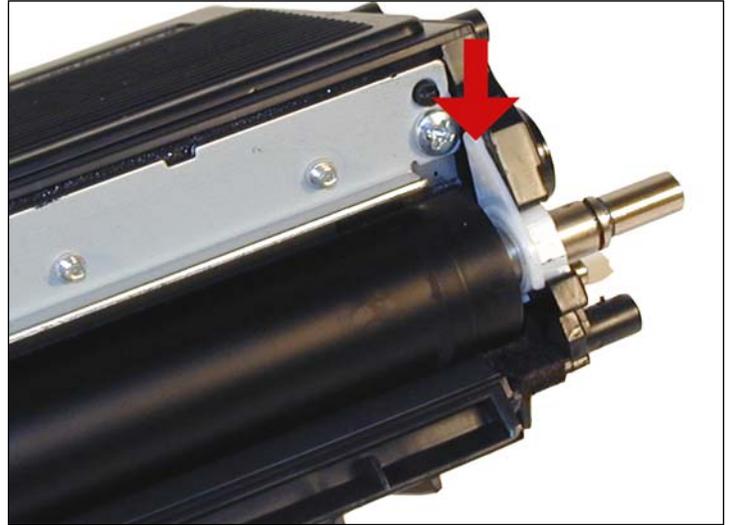
14. Clean the developer roller with a lint free cloth. Do not use any chemicals other than a dedicated cleaner for Brother rollers to clean the roller. A dry clean cloth will work fine.

Re-install the developer roller long shaft side to the gear side, and white lock pointing up. Turn the lock towards the doctor blade until it locks in place.

2) If the developer roller in the toner cartridge is worn, it will tend to pull too much toner, and back-grounding will result. This normally happens only on cartridges that have been recycled a few times. A normal roller will have a somewhat mottled look, and the texture should be smooth. If the roller has lines, small cracks, or just doesn't look right, don't use it.

A dirty developer roller can also cause this. If the roller has a white or bluish coating, it must be cleaned. Be sure to use only a dedicated Brother developer roller cleaner. Any other type of cleaner will probably react with the toner and cause another set of problems.

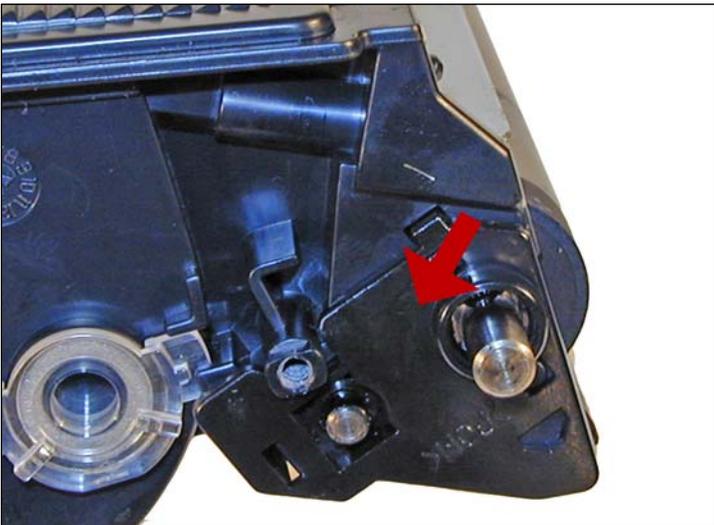
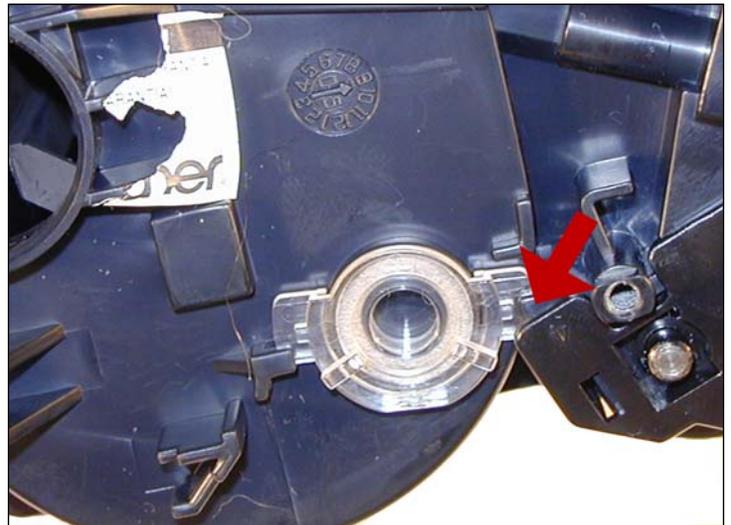
15. Install the small outside end plate on the non-gear side.
Make sure the clear plastic plug for the optical sensor is locked in the proper position.

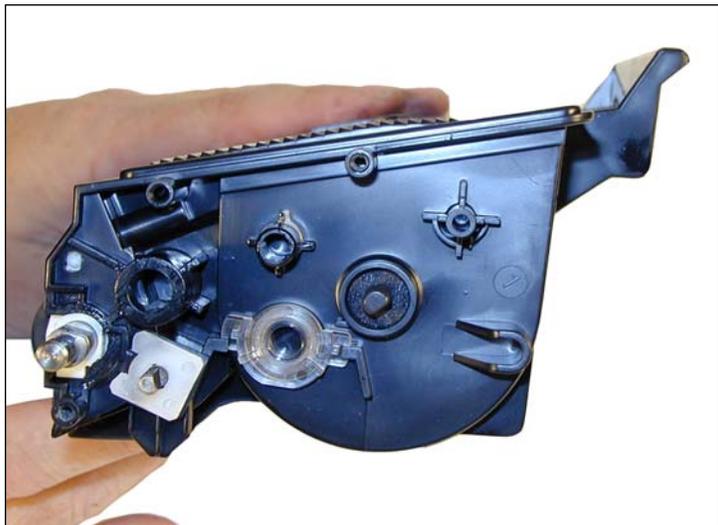
16. Clean the gears, making sure that they have no toner on them. This is a good time to also check the gear shafts to make sure there is enough grease. If the shafts appear dry, or the grease is contaminated with toner, clean the shaft and inside of the gear. Replace the grease with white lithium grease.

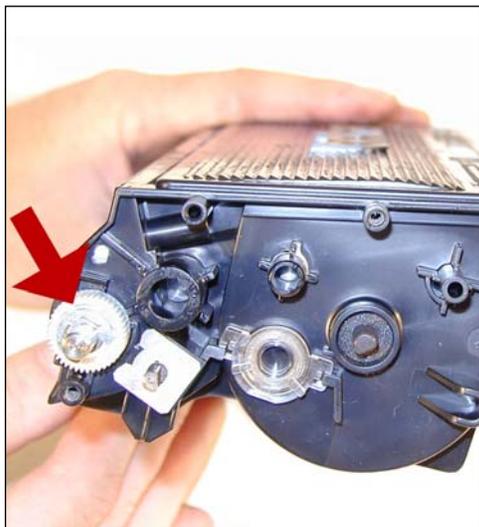
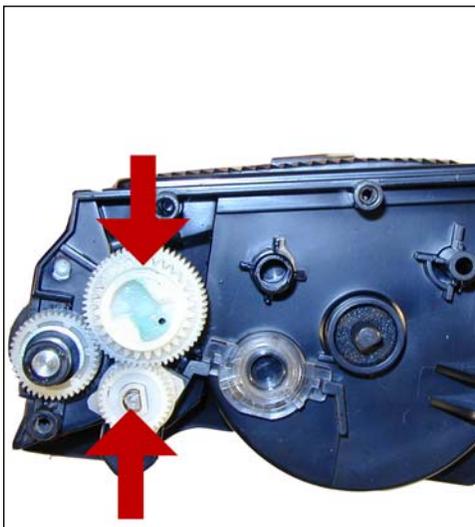
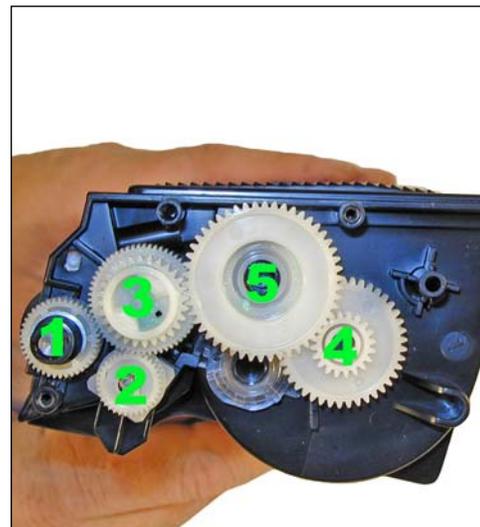
17. Install the developer roller gear, c-ring, black axle, and the rest of the gears. Make sure all the gears are meshing properly.

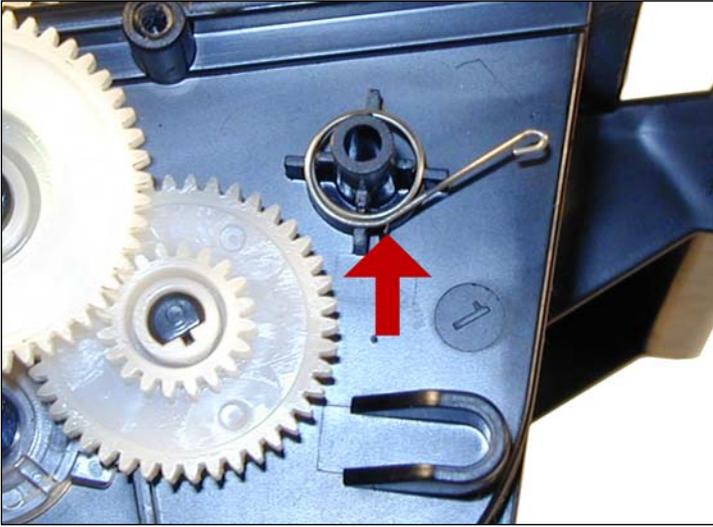
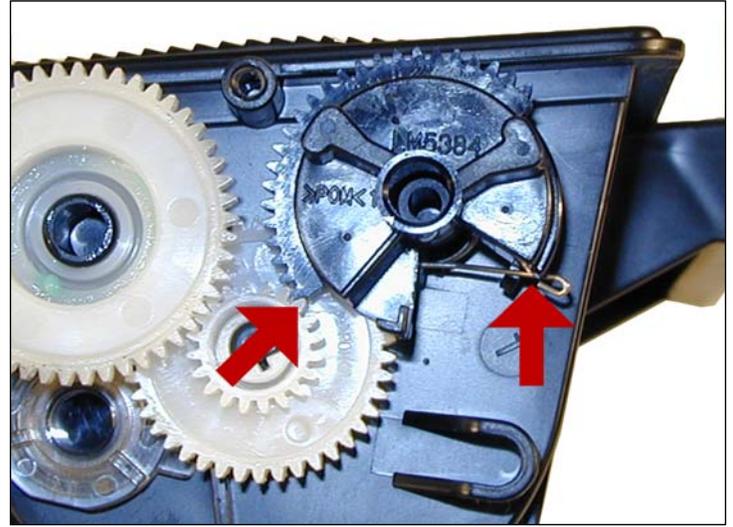
18. Set the reset gear and spring as shown. The straight tail of the spring fits into a notch at the base of the gear shaft. The teeth of the reset gear should start to mesh with the other gear as shown.

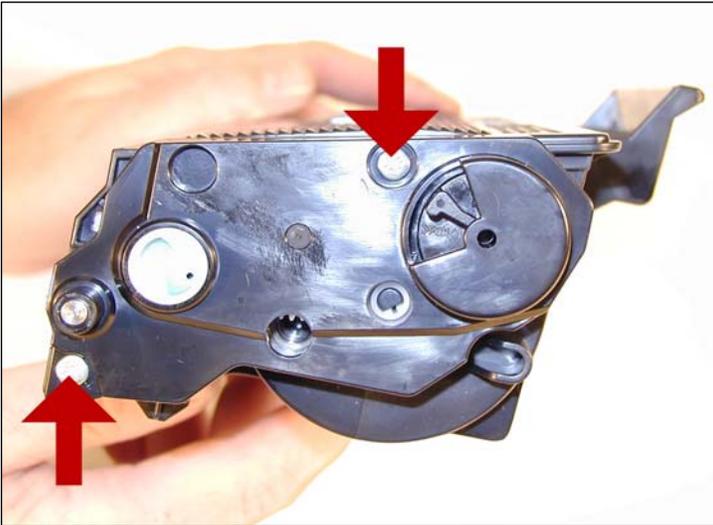
19. Install the gear cover plate, and two screws.

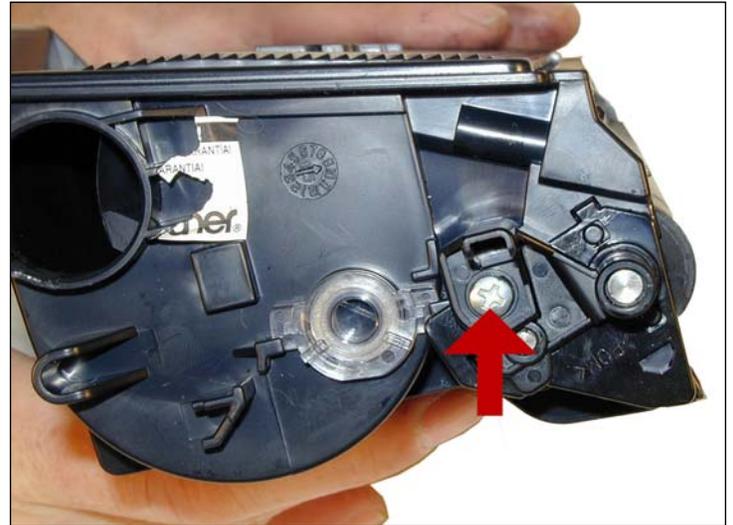
20. Install the drum axle plate on the non gear side and screw.

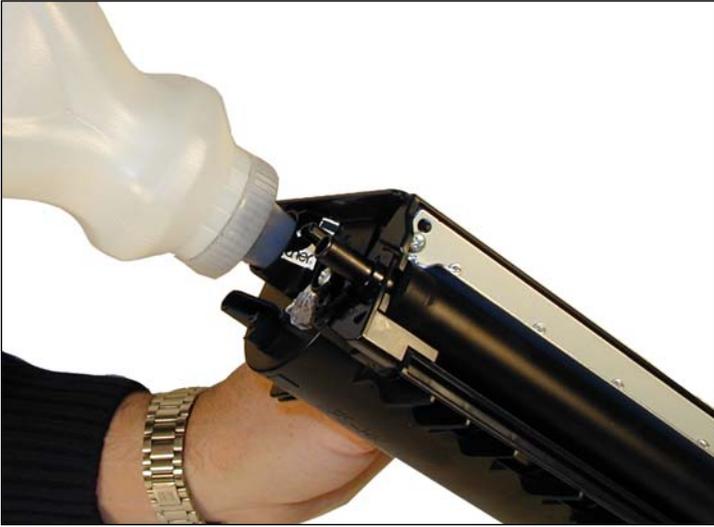
21. Fill the cartridge with Brother 5200 Black Toner.

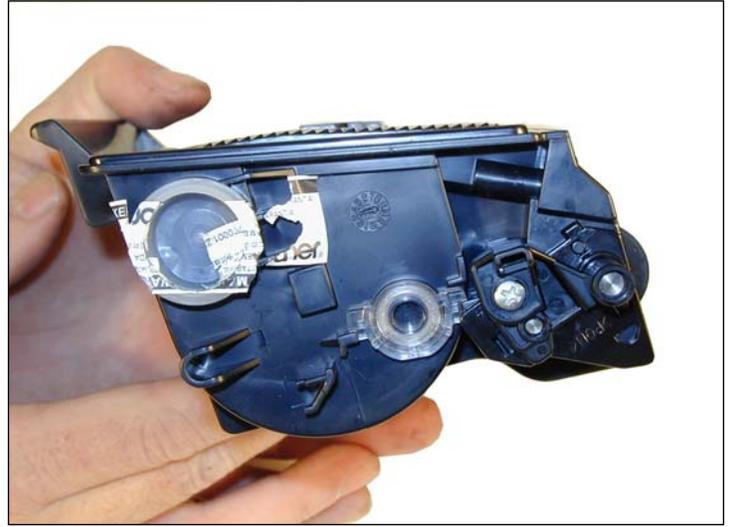
22. Replace the fill plug.
Wipe the cartridge down to remove any remaining toner dust.

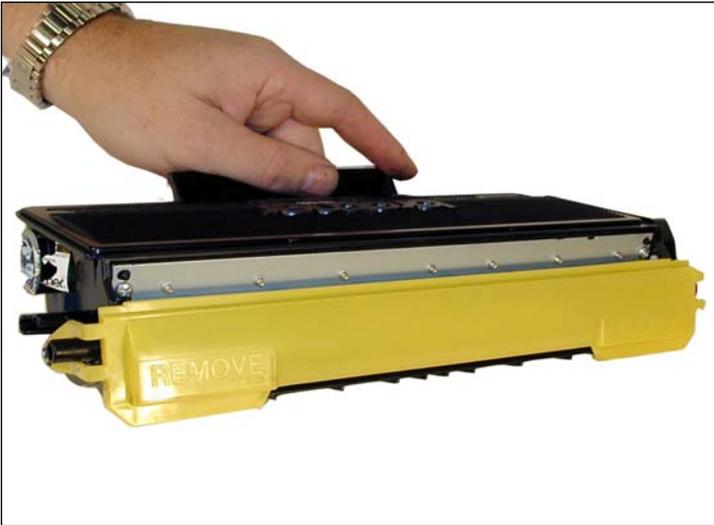
23. Install the developer roller cover.
