MINOLTA® PAGEPRO 8 • PAGEWORKS 8 TONER CARTRIDGE REMANUFACTURING INSTRUCTIONS

REMANUFACTURING THE MINOLTA PAGEWORKS 8 TONER CARTRIDGE

By Mike Josiah and the Technical Staff at UniNet

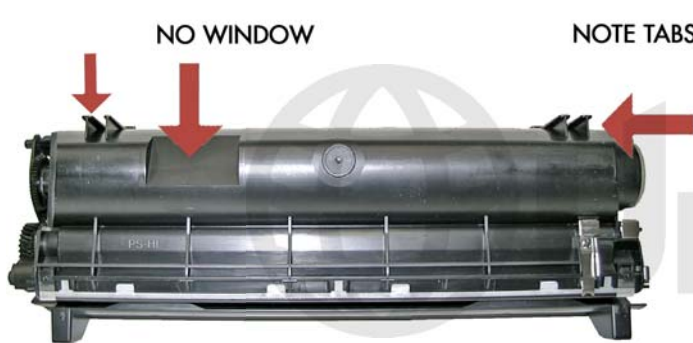
NEC SUPERSCRIPT 870 TONER
(20-120/20-122)

There are quite a few different versions of these cartridges in the field. The differences are that the fins on the back side of the cartridge are in different places, and that the fax cartridges have windows, where the printer cartridges do not.

These images show some of the different versions we have been able to find...

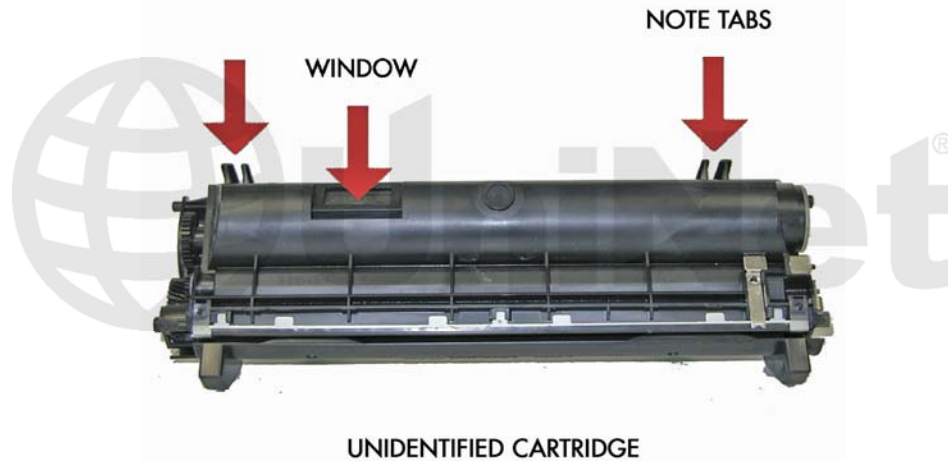
Pictured is an unidentified cartridge. When sorting these cartridges, make sure you note that there are both small and large fins. Cartridges may have similar fin locations, but different sized fins. The cartridges can be made universal by cutting the fins off. If you do this, make sure that you have a FAX universal, and a PRINTER universal cartridge. Cartridges without a window will not work in fax machines regardless of the fins.

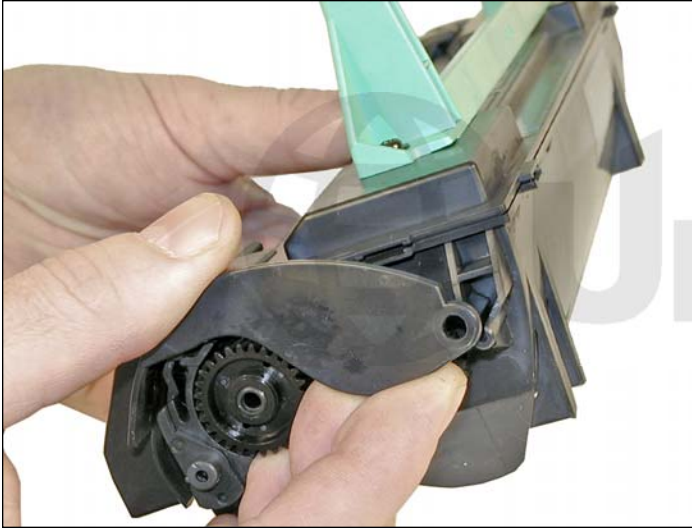
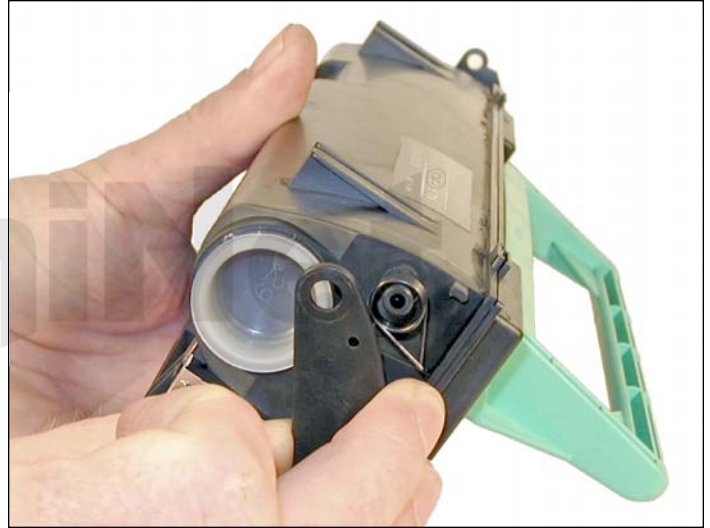
1. Locate the spring-loaded cover that protects the developer roller. Remove the cover by prying out on both ends where they contact the cartridge. A spring will come loose. We will show you how to re-install it later.

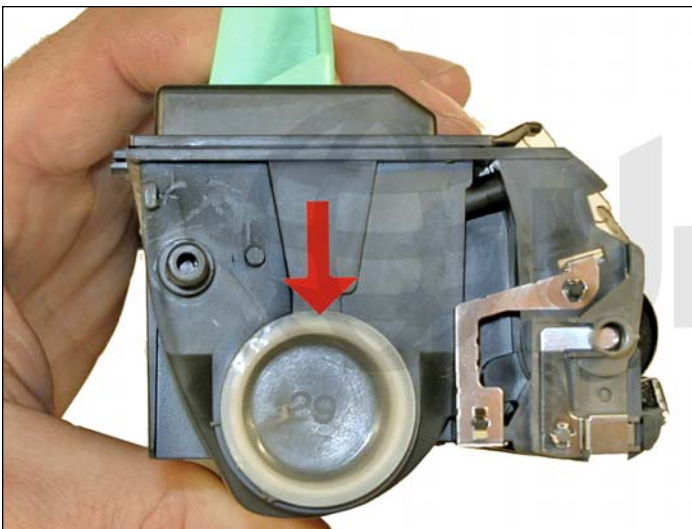
2. Remove the fill plug on the left side of the cartridge. Dump out the remaining toner. Lightly vacuum or blow off the outside of the housing and the developer roller. As stated above, in order to have a cartridge that functions properly, the developer roller must be removed, and the doctor blade cleaned.

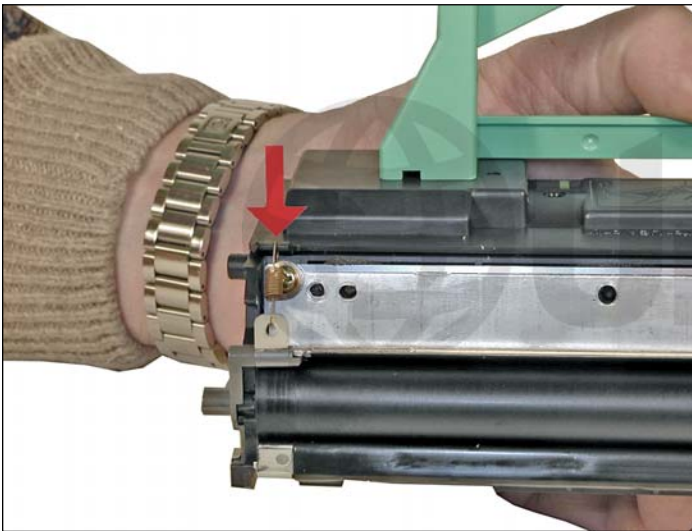
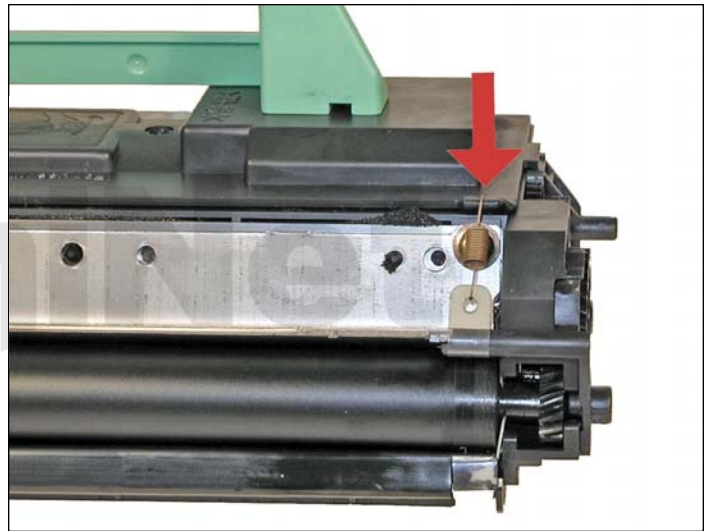
3. Remove the two springs located on either end of the doctor blade.

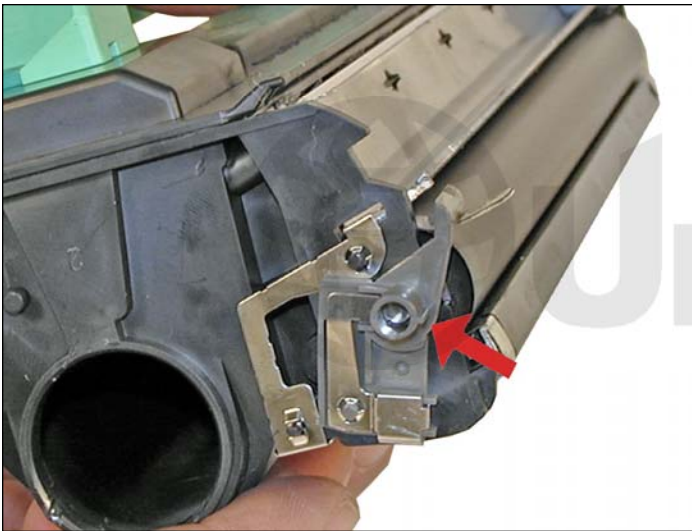
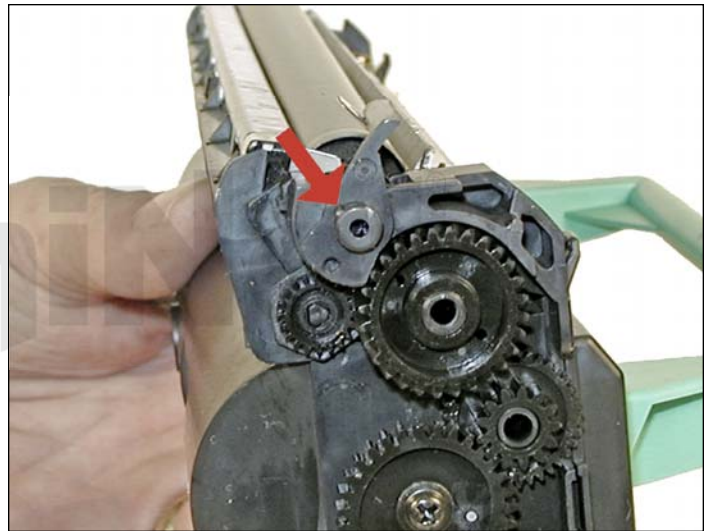
4. Remove the small hubs from both sides of the developer roller.

The contact hub is removed from the left side and the non-contact hub from the right.

These hubs can be black or gray in color.

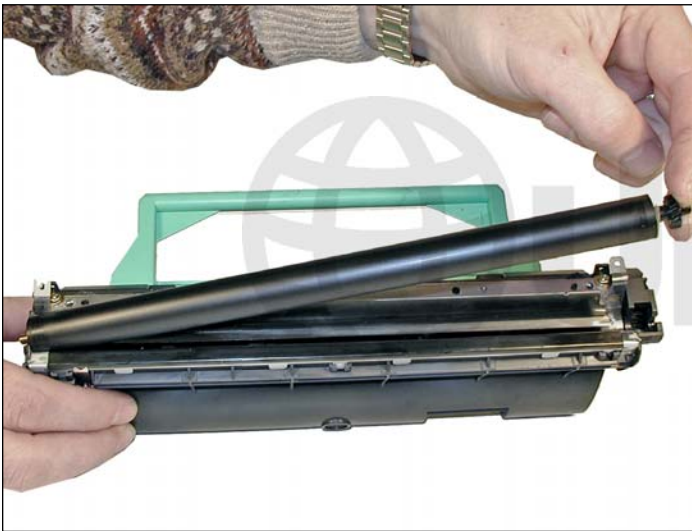
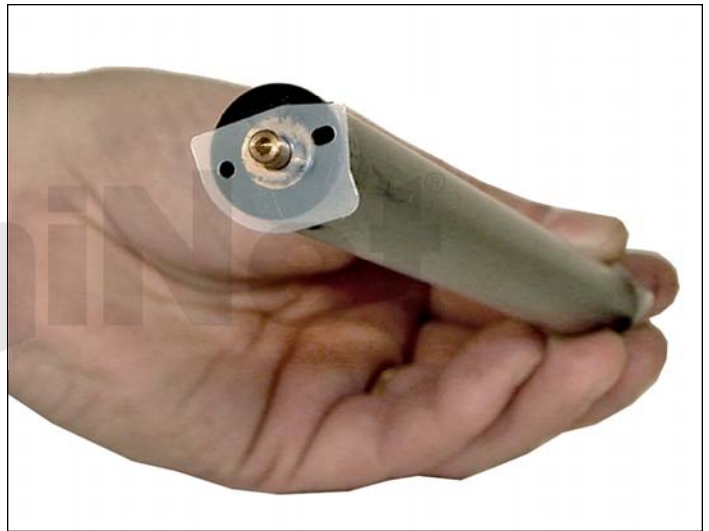
5. Remove the developer roller assembly, and the plastic shims on both sides.

Clean the developer roller sleeve with a lint-free cotton cloth, and place aside.

Do not use any chemicals to clean this roller!

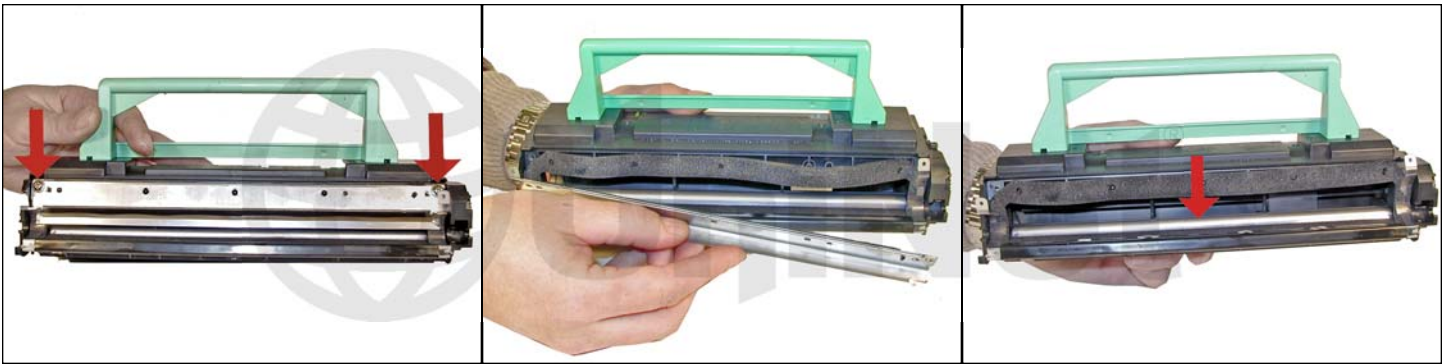
6. Remove the two screws and the doctor blade. When the doctor blade is removed, more than likely the seal foam will come with it. Carefully remove the foam from the back of the blade. Clean the rest of the toner from the hopper, and the metal feed roller. The doctor blade should be removed so that the acetone does not accidentally drip into the hopper. **NOTE:** When vacuuming or blowing out the hopper, be very careful not to damage the seal foam. Hold it in place as you clean.

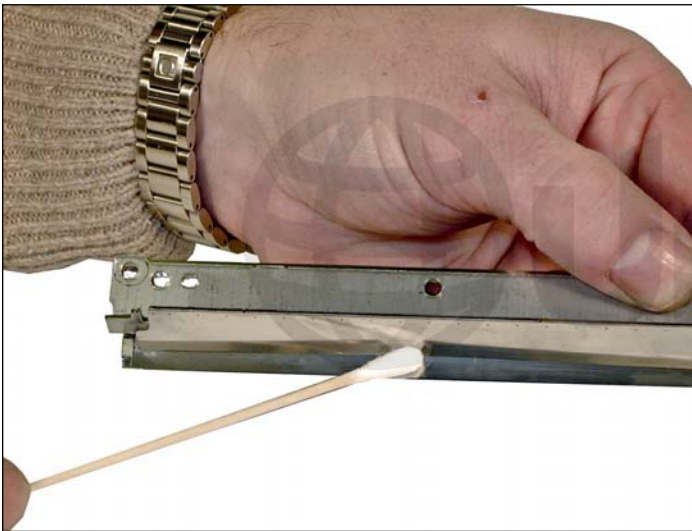
7. Clean the doctor blade with a cotton swab and acetone. Do not press hard or the blade will bend, Let the acetone do the work. Clean off any residue with a fresh swab and alcohol. This blade must be perfectly smooth. Any remaining buildup on this blade will cause streaking. Make sure it is completely dry when done.

First and foremost, if you are remanufacturing these cartridges, the doctor blade **MUST** be thoroughly cleaned. Failure to do this will cause streaking. There are many methods being done to clean them, but only one is fool-proof. We have seen many methods from just blowing the cartridge out, to taking a small plastic card and inserting it behind the developer roller, and sliding it across the doctor blade to scrape the blade clean. Neither of these methods really works, the cartridge may not streak at first, but it will, sooner rather than later. To remanufacture these cartridges correctly, the developer roller has to be removed, and the doctor blade cleaned with acetone. Acetone is the only chemical that we have found that removes all the buildup of toner from the blade. It is a fairly common cleaner available at most hardware stores. Although acetone is an excellent cleaner, it does leave some residue; we recommend cleaning the blades again with isopropyl alcohol to remove such residue.

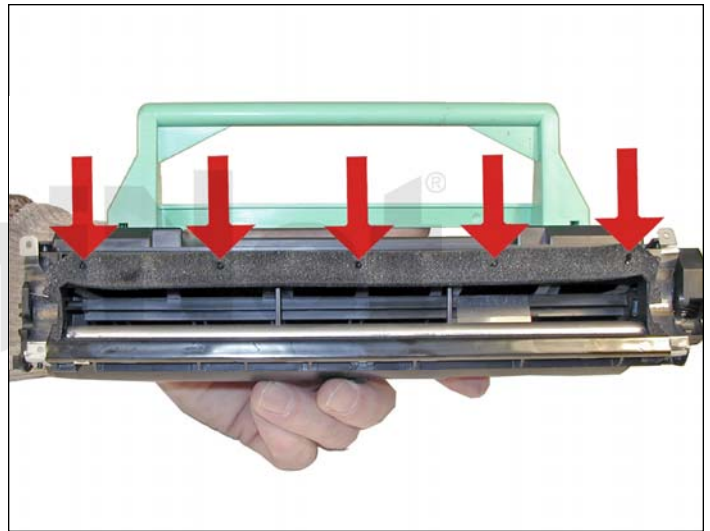
8. Re-align the seal foam on the five small posts.

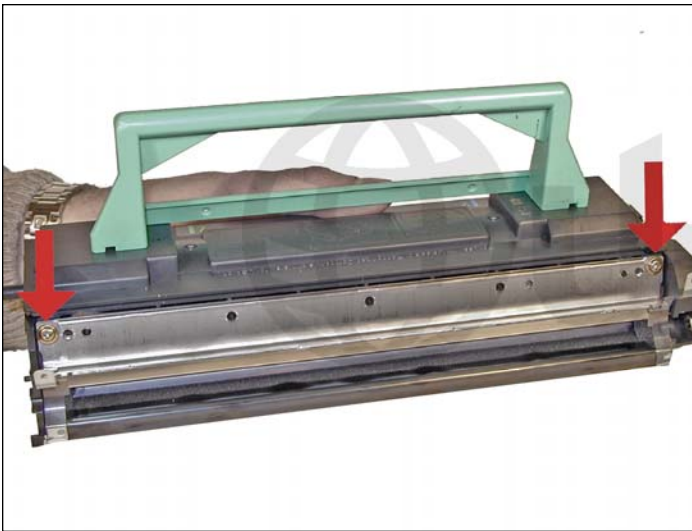
9. Install the doctor blade and two screws.

Make sure that the foam stays in place.

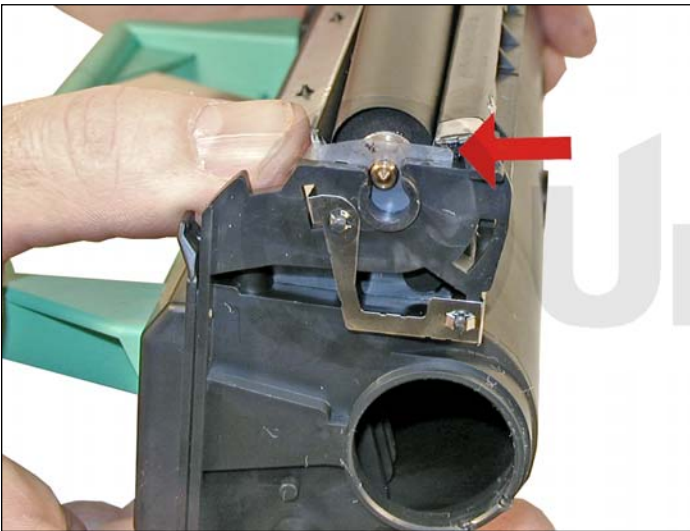
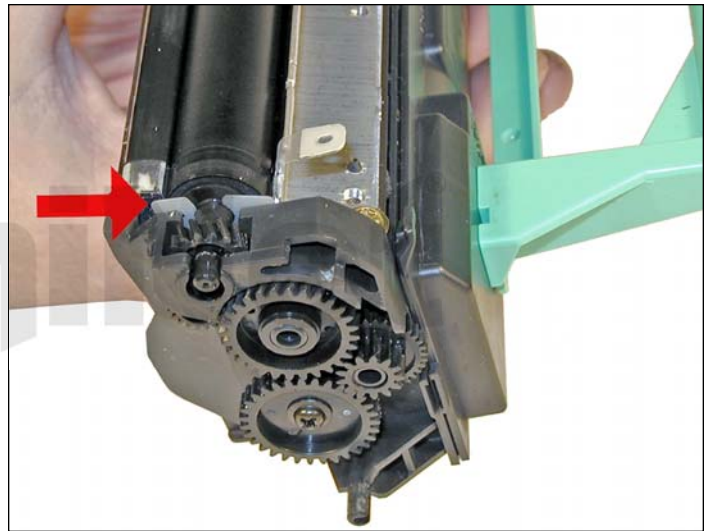
10. Install the cleaned developer roller with the two shims into the hopper.

Make sure that the two shims are flat side up.

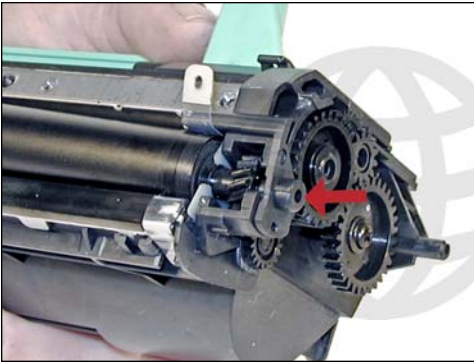
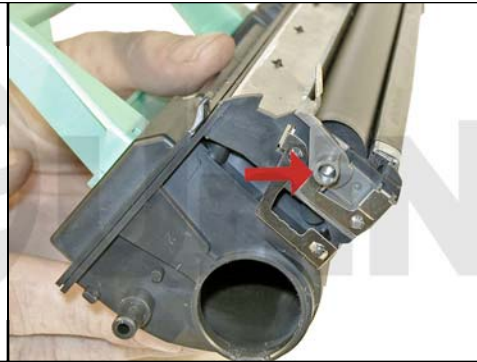
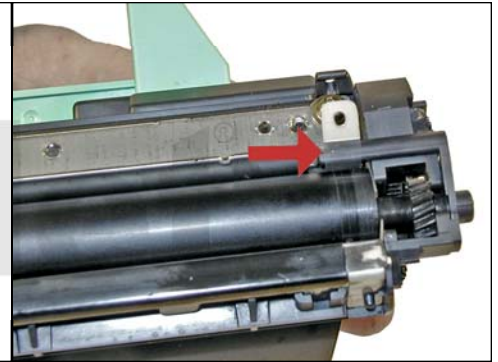
11. Install the two developer roller hubs: contact hub on the left, non-contact hub on the right.

Make sure that the clear plastic strips fit over the hub tabs.

Toner leaking from either edge of the cartridge: The clear strip and spring are not set right. Make sure the spring is attached, and that the strip is over the plastic tab.

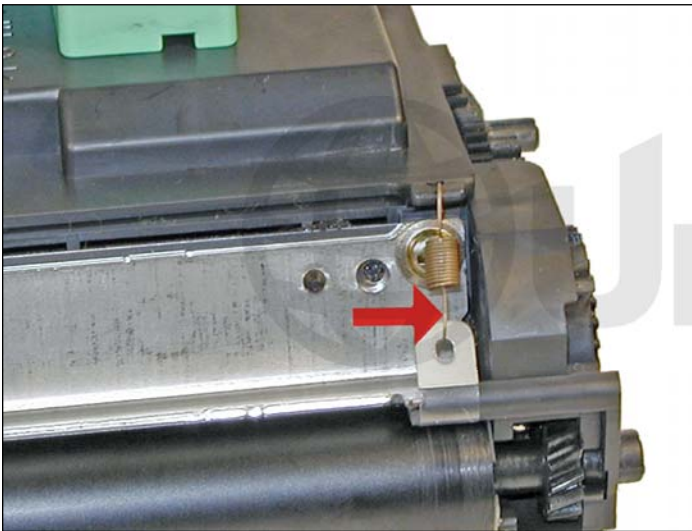
12. Install the springs on both sides of the doctor blade. Make sure that the open side of the spring is facing towards the doctor blade.

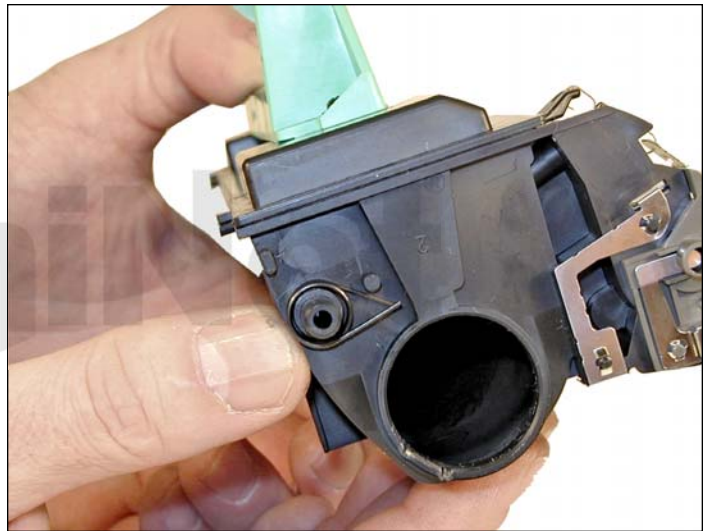
13. Set the drum cover spring onto the shaft as shown.

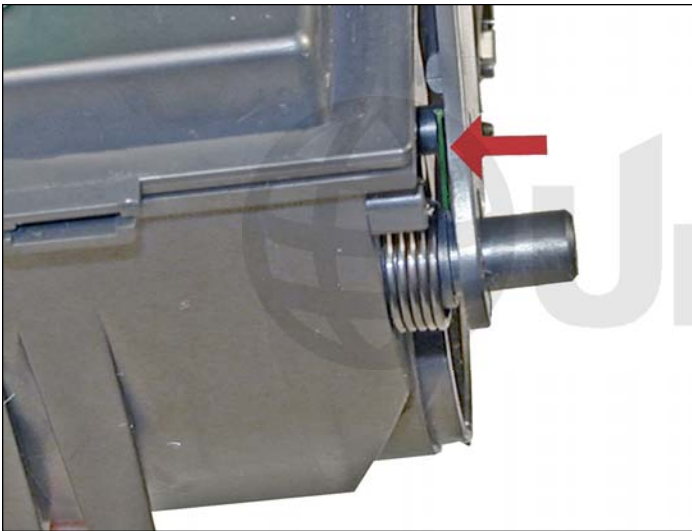
14. Install the cover. Pull the upper tail of the spring to engage the tab on the drum cover. The tail of the spring has been colored to see it better. The drum cover should move easily, and fully close on its own.

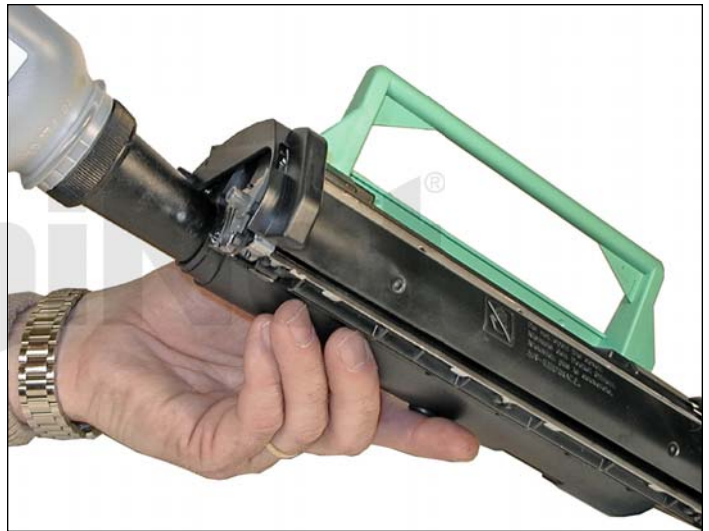
15. Fill the cartridge with toner for use in PageWorks 8.
